FACILITY CONDITION ASSESSMENT

Plainfield Public Schools
651 Norwich Road
Plainfield, Connecticut 06374
John Richards

Plainfield Memorial School
95 Canterbury Road
Plainfield, Connecticut 06374

October 31, 2023

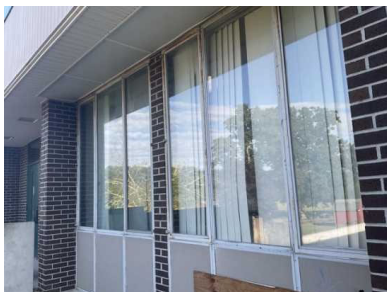
**Window in Poor condition.**

Aluminum Double-Glazed, 28-40 SF
Plainfield Memorial School Building Exterior

The windows in the original section of the building are dated and have reported issues that were confirmed through observation. Upgrading the windows to efficient double-glazed units is recommended. - AssetCALC ID: 6974067

Uniformat Code: B2020
Recommendation: **Replace in 2024**

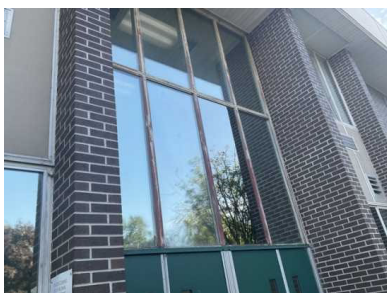
**Storefront in Poor condition.**

Glazing and Framing
Plainfield Memorial School Building Exterior

The windows in the original section of the building are dated and have reported issues that were confirmed through observation. Upgrading the windows to efficient double-glazed units is recommended. - AssetCALC ID: 6974057

Uniformat Code: B2020
Recommendation: **Replace in 2024**

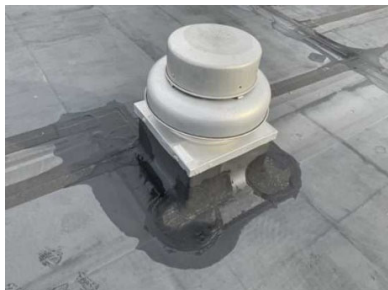
**Exhaust Fan in Poor condition.**

Roof or Wall-Mounted, 12" Damper
Plainfield Memorial School Roof

The exhaust fans date from 1992 and generally have issues with reliability and performance. Upgrading the fans is recommended. - AssetCALC ID: 6974061

Uniformat Code: D3060
Recommendation: **Replace in 2024**

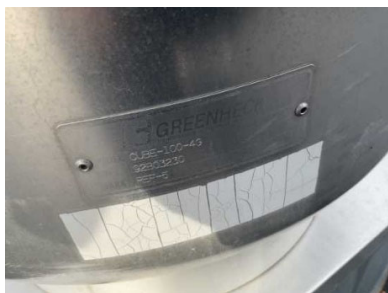
**Exhaust Fan in Poor condition.**

Roof or Wall-Mounted, 16" Damper
Plainfield Memorial School Roof

The exhaust fans date from 1992 and generally have issues with reliability and performance. Upgrading the fans is recommended. - AssetCALC ID: 6974035

Uniformat Code: D3060
Recommendation: **Replace in 2024**

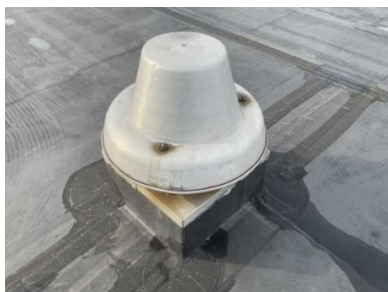
**Exhaust Fan in Poor condition.**

Roof or Wall-Mounted, 16" Damper
Plainfield Memorial School Roof

The exhaust fans date from 1992 and generally have issues with reliability and performance. Upgrading the fans is recommended. - AssetCALC ID: 6974028

Uniformat Code: D3060
Recommendation: **Replace in 2024**

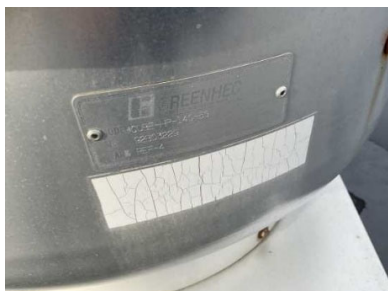
**Exhaust Fan in Poor condition.**

Roof or Wall-Mounted, 16" Damper
Plainfield Memorial School Roof

The exhaust fans date from 1992 and generally have issues with reliability and performance. Upgrading the fans is recommended. - AssetCALC ID: 6973983

Uniformat Code: D3060
Recommendation: **Replace in 2024**

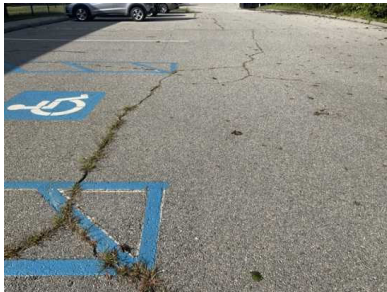
Parking Lots in Poor condition.

Pavement, Asphalt
 Plainfield Memorial School Site

The pavement surface exhibits significant cracking. Sealing and stripping the cracks is recommended to bolster the integrity and lengthen the life of the asphalt pavement. - AssetCALC ID: 6974024

Uniformat Code: G2020
 Recommendation: **Seal and Stripe in 2023**

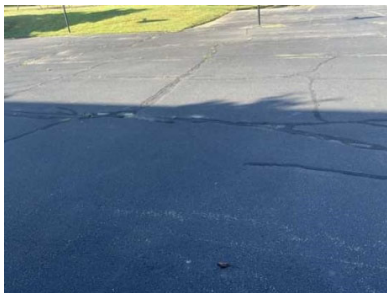
Athletic Surfaces and Courts in Poor condition.

Basketball/General, Asphalt Pavement
 Plainfield Memorial School Site

The pavement surface exhibits significant cracking. Sealing and stripping the cracks is recommended to bolster the integrity and lengthen the life of the asphalt pavement. - AssetCALC ID: 6974070

Uniformat Code: G2050
 Recommendation: **Seal and Stripe in 2023**

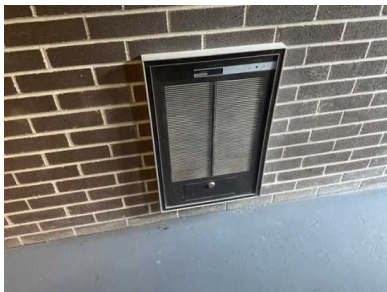
Unit Heater in Poor condition.

Electric
 Plainfield Memorial School Entryways

The wall-mounted electric heaters date from 1992 and are recommended for replacement as part of an overall HVAC renovation. - AssetCALC ID: 6974080

Uniformat Code: D3020
 Recommendation: **Replace in 2024**

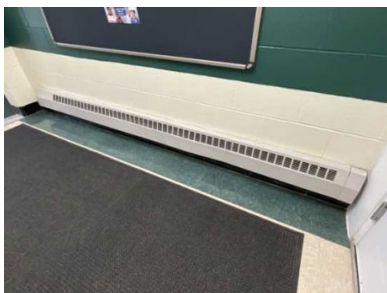
Baseboard Heater in Poor condition.

Electric, 6 LF
 Plainfield Memorial School Throughout building

The electric baseboard heaters date from 1992 and are recommended for replacement as part of an overall HVAC renovation. - AssetCALC ID: 6974056

Uniformat Code: D3020
 Recommendation: **Replace in 2024**

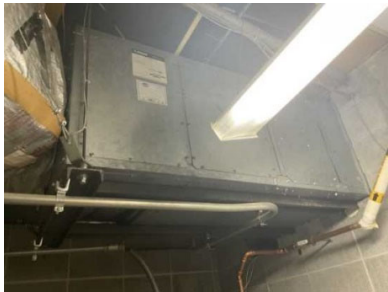
Air Handler in Poor condition.

Interior AHU, Easy/Moderate Access, 801 to 1200 CFM
Plainfield Memorial School Kitchen closet

The air handler dates from 1992 and generally have issues with reliability and performance. Upgrading the AHU is recommended. - AssetCALC ID: 6974034

Uniformat Code: D3050
Recommendation: **Replace in 2024**

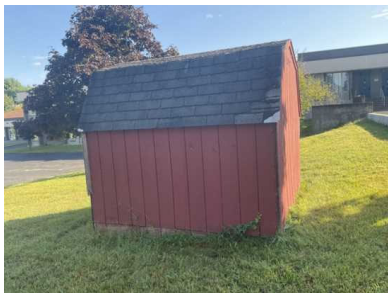
Shed/Gazebo/Shade Structure in Poor condition.

Wood or Metal-Framed, Basic/Minimal
Plainfield Memorial School Site

The storage shed shows evidence of significant wear and tear. A new shed is recommended. - AssetCALC ID: 6974011

Uniformat Code: F1020
Recommendation: **Replace in 2024**
