FACILITY CONDITION ASSESSMENT

Plainfield Central Middle School
75 Canterbury Road
Plainfield, Connecticut 06374

163022.23R000-005.379

October 31, 2023

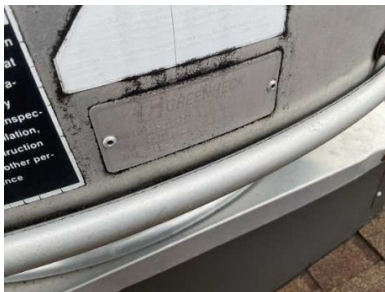
**Exhaust Fan in Failed condition.**

Roof or Wall-Mounted, 24" Damper
Plainfield Central Middle School Roof

The exhaust fans dating from 1992 have far exceeded their estimated useful life. The fans should be upgraded as part of an overall HVAC renovation. - AssetCALC ID: 6961071

Uniformat Code: D3060
Recommendation: **Replace in 2024**

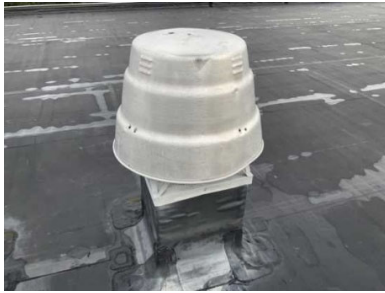
**Exhaust Fan in Poor condition.**

Roof or Wall-Mounted, 16" Damper
Plainfield Central Middle School Roof

The exhaust fans are original to the building and more than double their estimated useful life. The fans should be upgraded as an overall HVAC renovation. - AssetCALC ID: 6961099

Uniformat Code: D3060
Recommendation: **Replace in 2024**

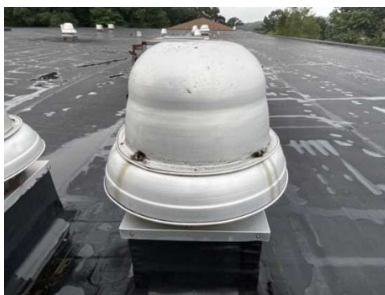
**Exhaust Fan in Poor condition.**

Roof or Wall-Mounted, 16" Damper
Plainfield Central Middle School Roof

The exhaust fans are original to the building and more than double their estimated useful life. The fans should be upgraded as an overall HVAC renovation. - AssetCALC ID: 6961002

Uniformat Code: D3060
Recommendation: **Replace in 2024**

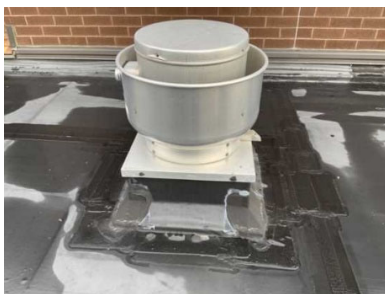
**Exhaust Fan in Poor condition.**

Roof or Wall-Mounted, 16" Damper
Plainfield Central Middle School Roof

The exhaust fans dating from 1992 have far exceeded their estimated useful life. The fans should be upgraded as part of an overall HVAC renovation. - AssetCALC ID: 6961066

Uniformat Code: D3060
Recommendation: **Replace in 2024**

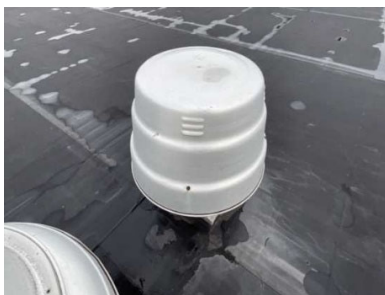
**Exhaust Fan in Poor condition.**

Roof or Wall-Mounted, 16" Damper
Plainfield Central Middle School Roof

The exhaust fans are original to the building and more than double their estimated useful life. The fans should be upgraded as an overall HVAC renovation. - AssetCALC ID: 6961040

Uniformat Code: D3060
Recommendation: **Replace in 2024**

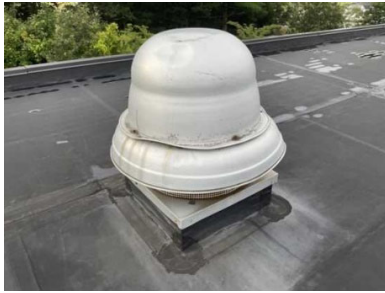
**Exhaust Fan in Poor condition.**

Roof or Wall-Mounted, 16" Damper
Plainfield Central Middle School Roof

The exhaust fans are original to the building and more than double their estimated useful life. The fans should be upgraded as an overall HVAC renovation. - AssetCALC ID: 6961119

Uniformat Code: D3060
Recommendation: **Replace in 2024**

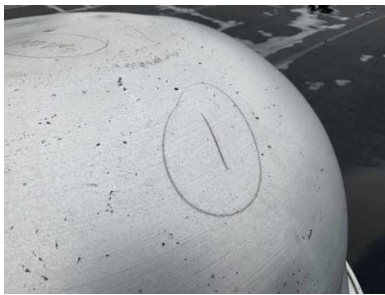
**Exhaust Fan in Poor condition.**

Roof or Wall-Mounted, 16" Damper
Plainfield Central Middle School Roof

The exhaust fans are original to the building and more than double their estimated useful life. The fans should be upgraded as an overall HVAC renovation. - AssetCALC ID: 6961026

Uniformat Code: D3060
Recommendation: **Replace in 2024**

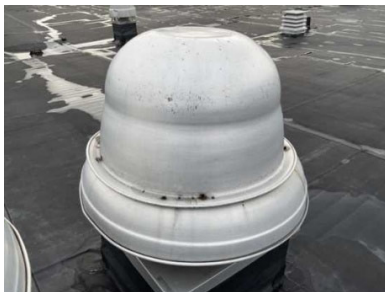
**Exhaust Fan in Poor condition.**

Roof or Wall-Mounted, 16" Damper
Plainfield Central Middle School Roof

The exhaust fans are original to the building and more than double their estimated useful life. The fans should be upgraded as an overall HVAC renovation. - AssetCALC ID: 6961110

Uniformat Code: D3060
Recommendation: **Replace in 2024**

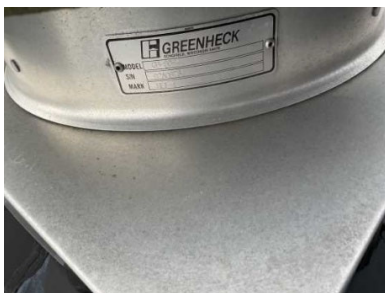
**Exhaust Fan in Poor condition.**

Roof or Wall-Mounted, 16" Damper
Plainfield Central Middle School Roof

The exhaust fans dating from 1992 have far exceeded their estimated useful life. The fans should be upgraded as part of an overall HVAC renovation. - AssetCALC ID: 6961111

Uniformat Code: D3060
Recommendation: **Replace in 2024**

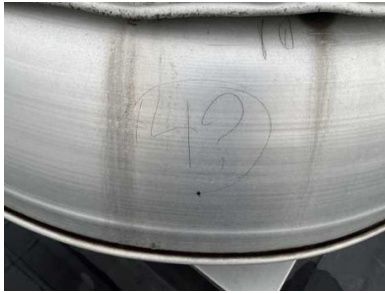
**Exhaust Fan in Poor condition.**

Roof or Wall-Mounted, 24" Damper
Plainfield Central Middle School Roof

The exhaust fans are original to the building and more than double their estimated useful life. The fans should be upgraded as an overall HVAC renovation. - AssetCALC ID: 6961015

Uniformat Code: D3060
Recommendation: **Replace in 2024**

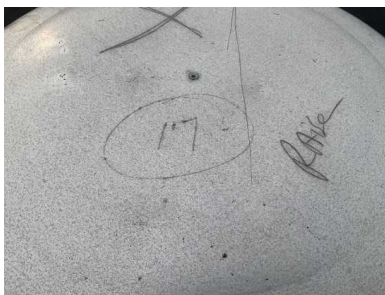
**Exhaust Fan in Poor condition.**

Roof or Wall-Mounted, 16" Damper
Plainfield Central Middle School Roof

The exhaust fans are original to the building and more than double their estimated useful life. The fans should be upgraded as an overall HVAC renovation. - AssetCALC ID: 6961028

Uniformat Code: D3060
Recommendation: **Replace in 2024**

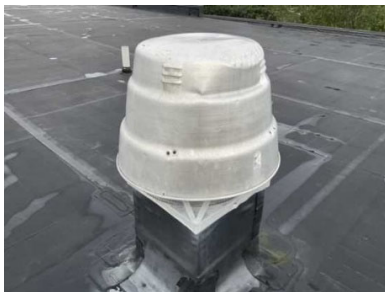
**Exhaust Fan in Poor condition.**

Roof or Wall-Mounted, 16" Damper
Plainfield Central Middle School Roof

Uniformat Code: D3060
Recommendation: **Replace in 2024**
