FACILITY CONDITION ASSESSMENT

Plainfield Public Schools
651 Norwich Road
Plainfield, Connecticut 06374
John Richards

Plainfield Memorial School
95 Canterbury Road
Plainfield, Connecticut 06374

October 31, 2023

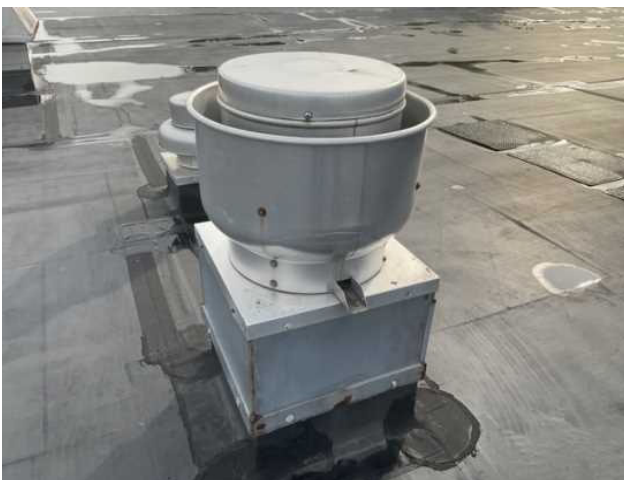
29 - EXHAUST FANS

The exhaust fans date from 1992 and generally have issues with reliability and performance. Upgrading the fans is recommended. - AssetCALC ID: 6974061

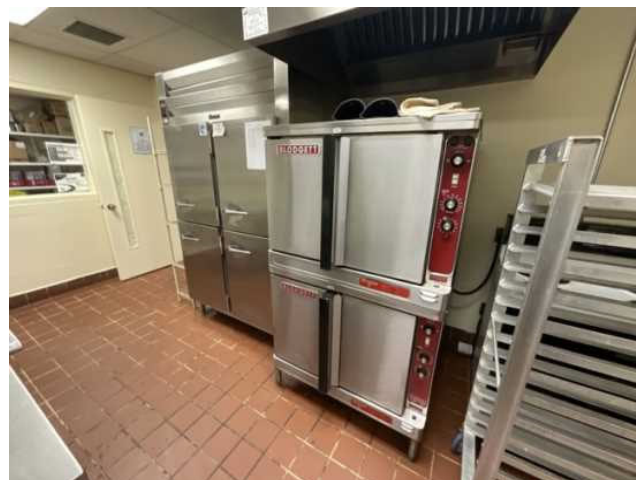
36 - FOODSERVICE EQUIPMENT

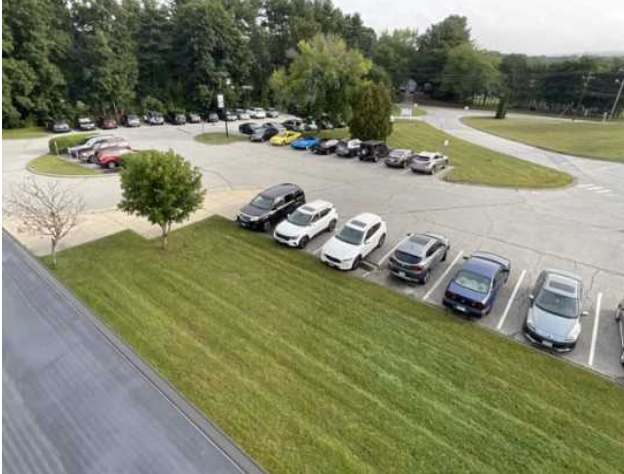
37 - MAIN PARKING AREA

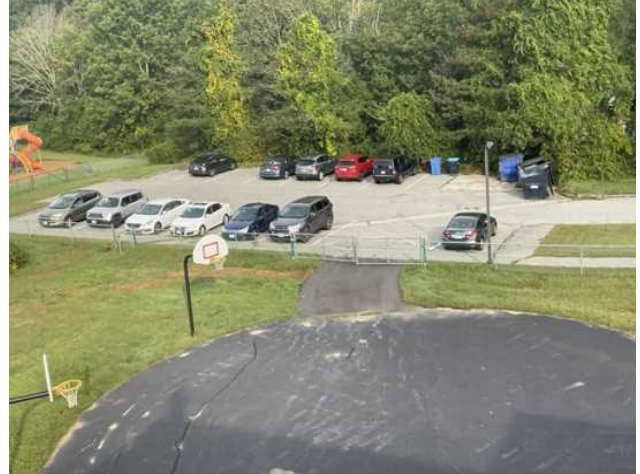
38 - SECONDARY PARKING AREA

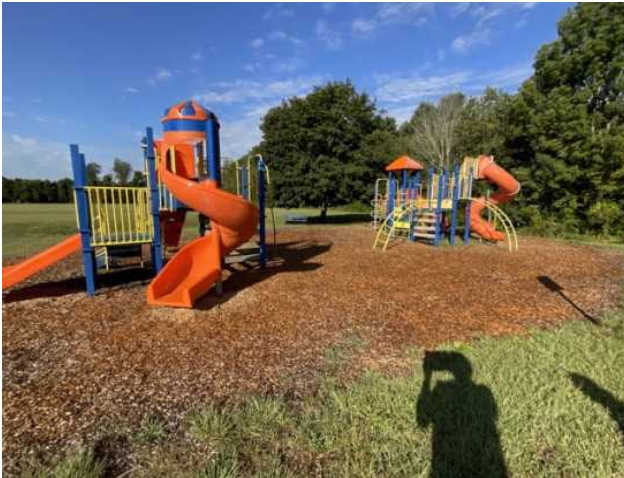
39 - OVERVIEW OF PLAYGROUND

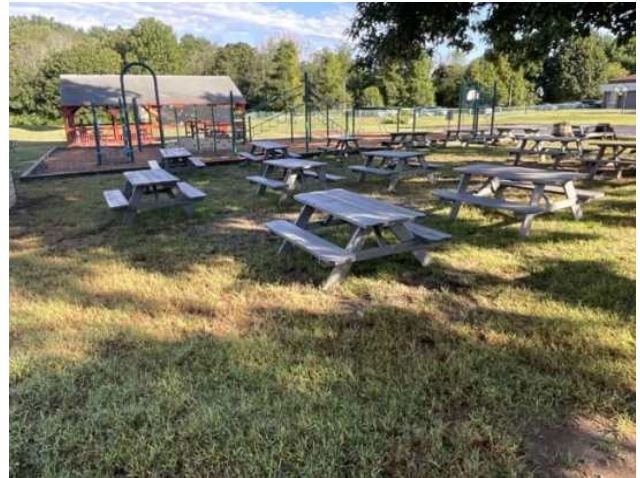
40 - OUTDOOR PICNIC AREA

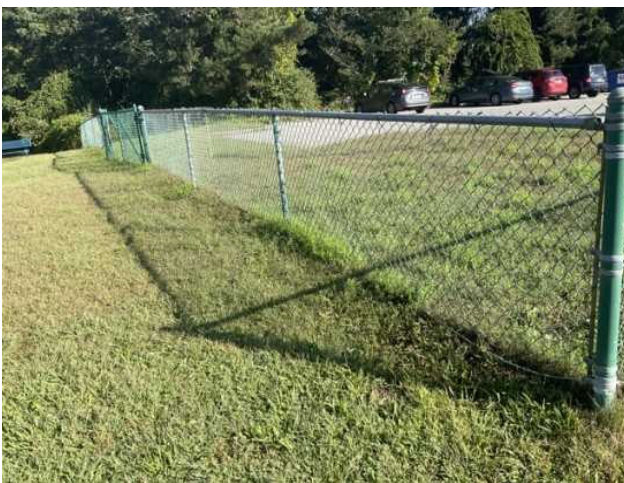
41 - SITE FENCING

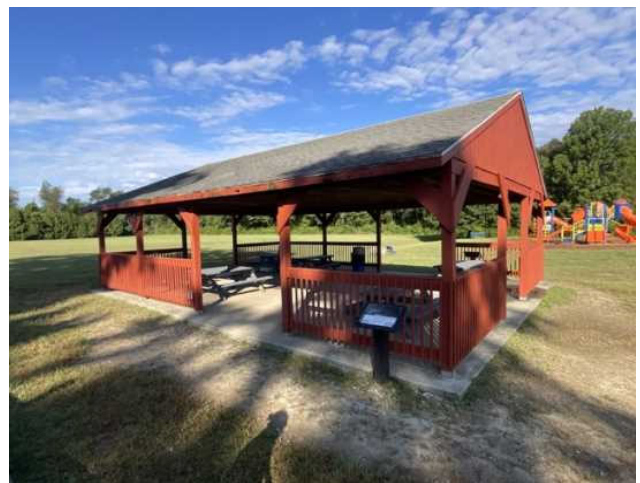
42 - SHADE STRUCTURE

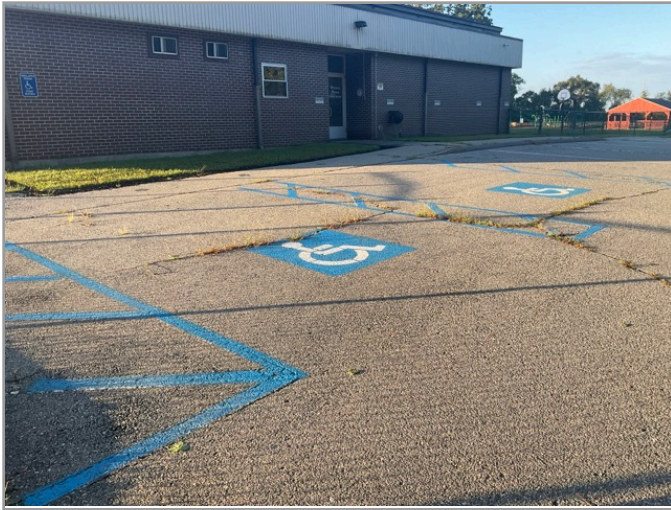
OVERVIEW OF ACCESSIBLE PARKING AREA

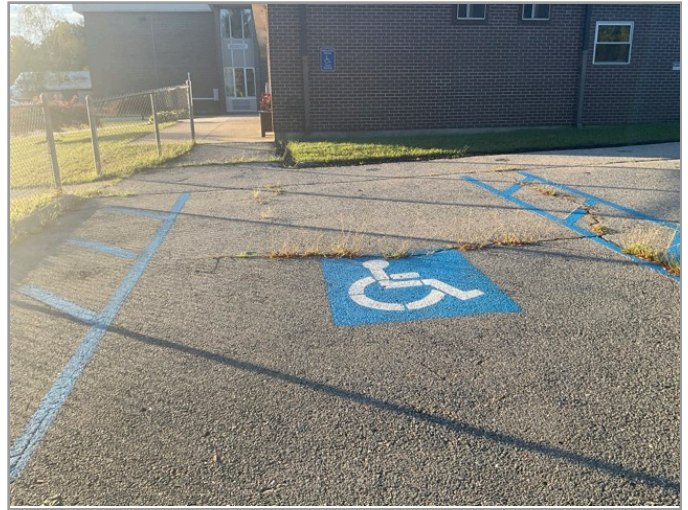
CLOSE-UP OF STALL

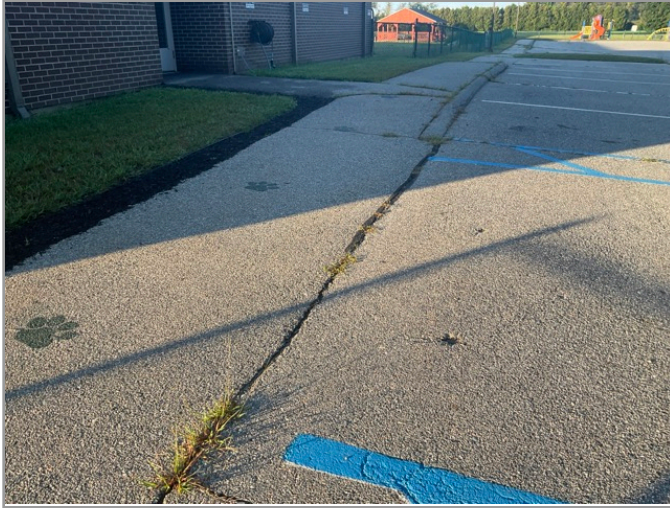
EXTERIOR ROUTE OF TRAVEL

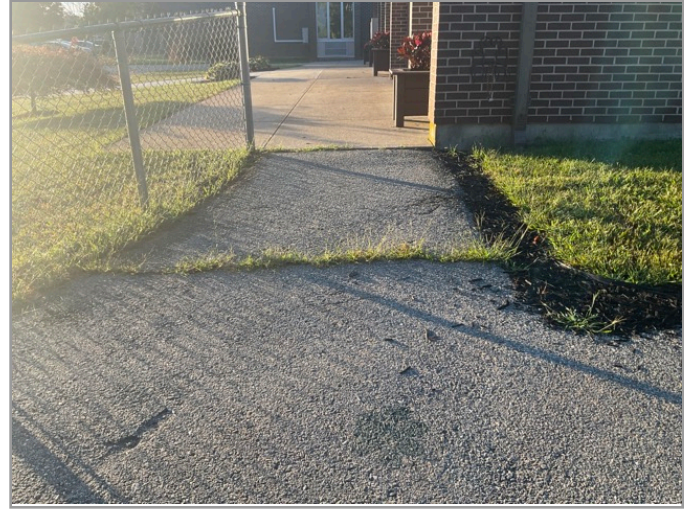
ACCESSIBLE PATH

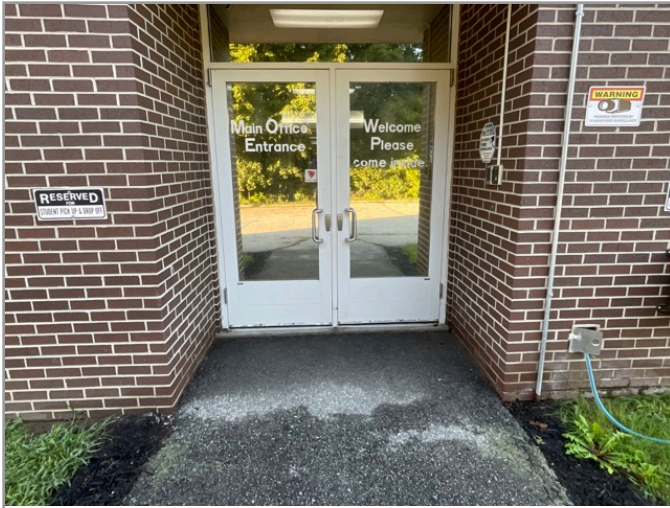
MAIN ENTRANCE

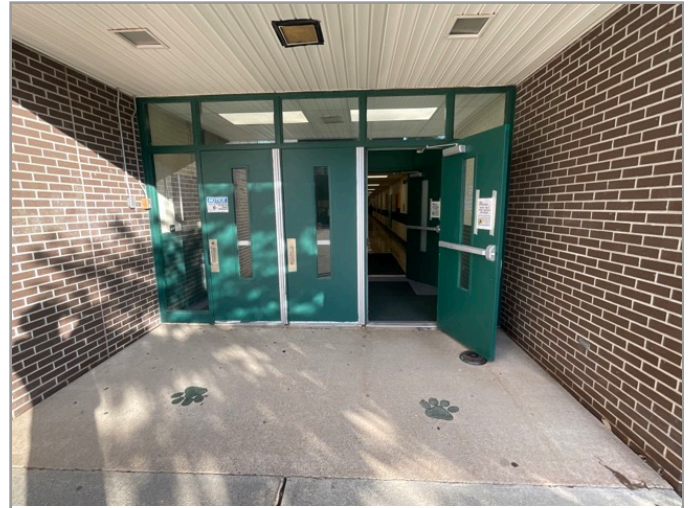
ADDITIONAL ENTRANCE

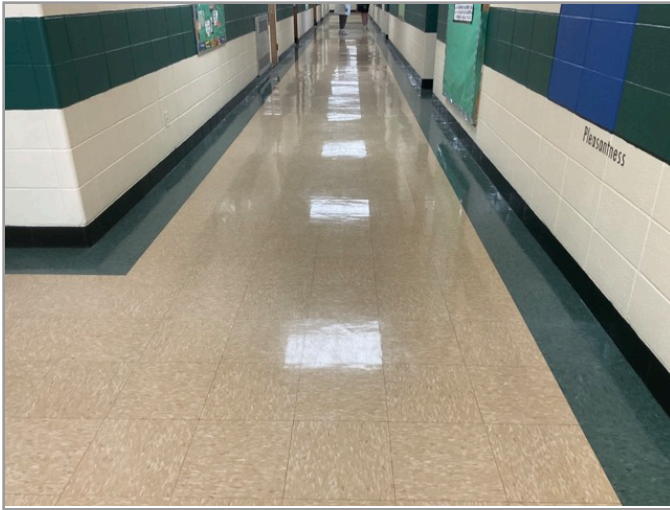
INTERIOR PATH OF TRAVEL

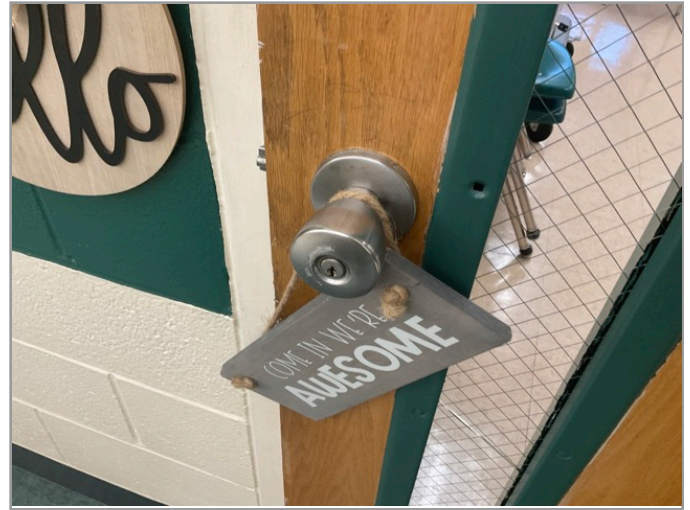
DOOR HARDWARE

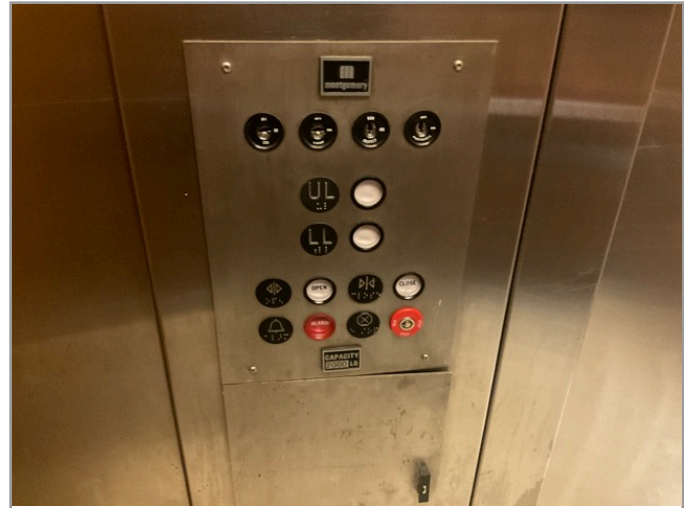
IN-CAB CONTROLS

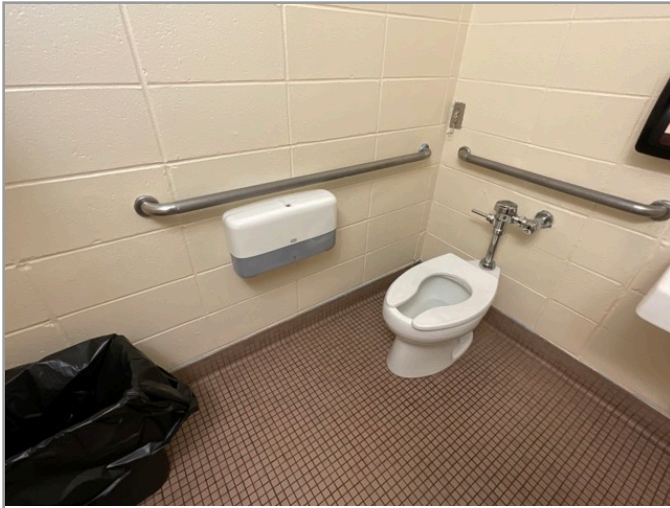
TOILET STALL OVERVIEW

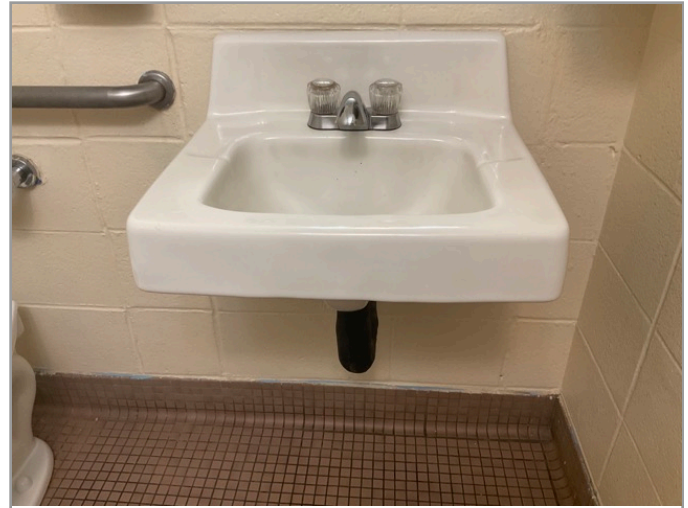
RESTROOM SINK

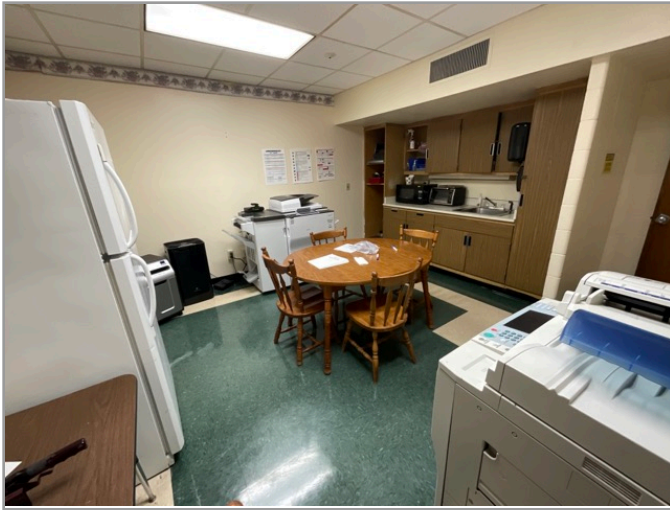
BREAKROOM OVERVIEW

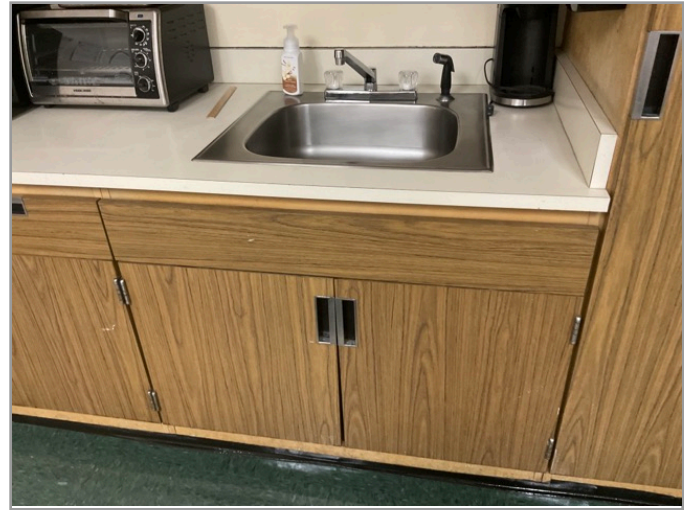
BREAKROOM SINK

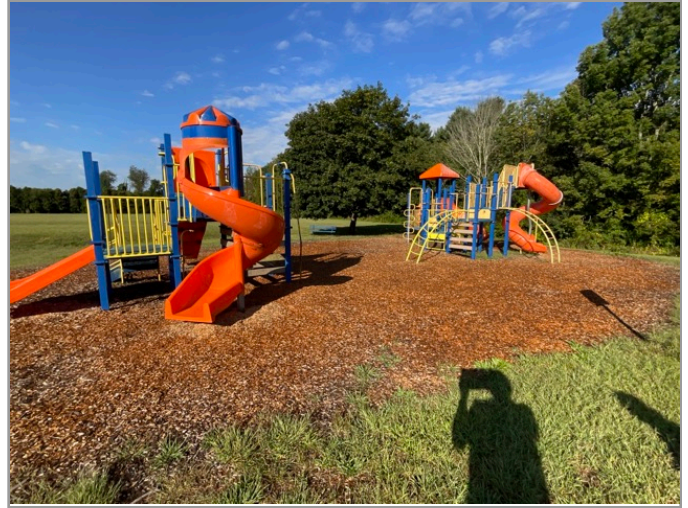
OVERVIEW OF PLAYGROUND
